Eagle Project

Impermeable Surface Inspection
and Surface Repair Plan

Kennecott Eagle Minerals Company
Michigamme Township, Michigan

December 2007

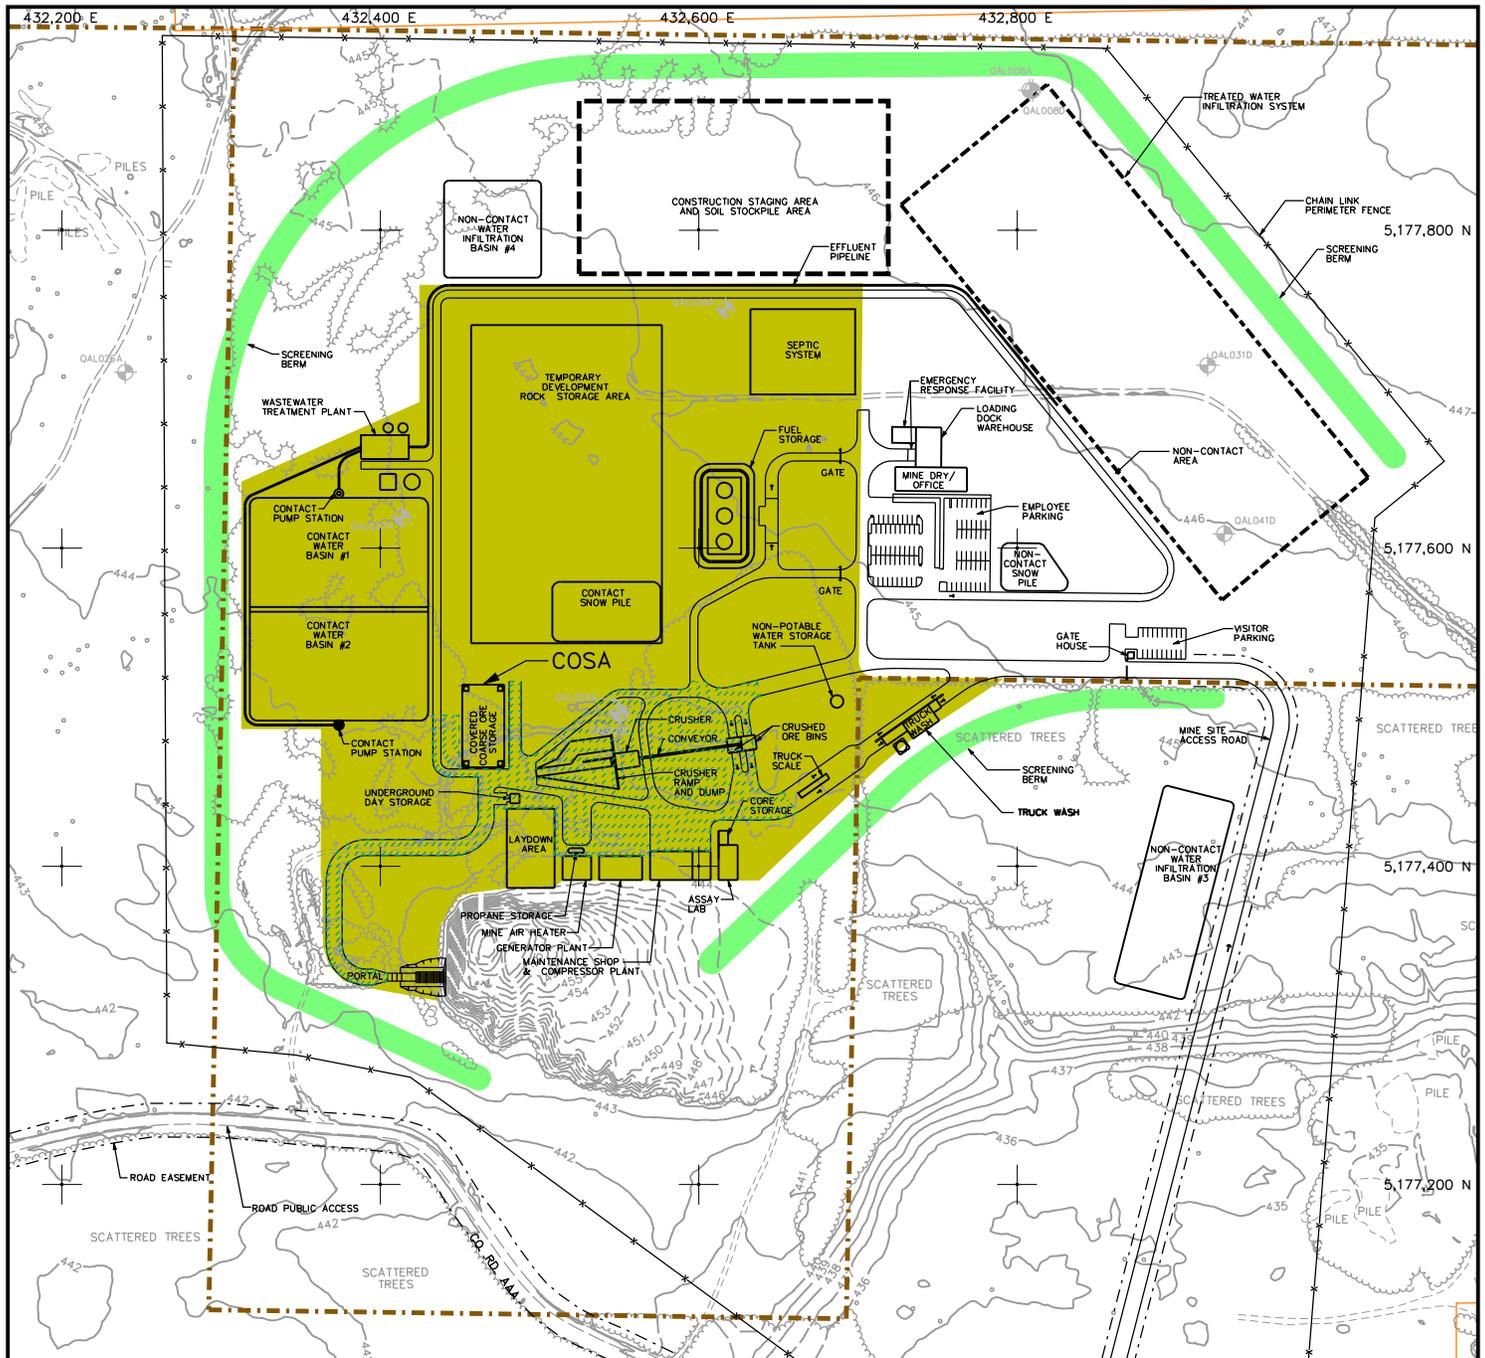
Figure 1 Contact Area Impermeable Surface

- EXISTING ELEV. CONTOUR IN METERS MSL
- UNPAVED ROAD
- TREE
- TREE LINE
- KENNECOTT PROPERTY BOUNDARY
- ROAD EASEMENT PROVIDE BY MCINTOSH ENGINEERING, INC., AUGUST, 2005
- TREATED WATER INFILTRATION SYSTEM
- PLANIMETRIC WETLAND NOTATION
- PERIMETER FENCE
- MAIN OPERATIONS AREA
- BITUMINOUS LINED OPERATIONS AREA
